Bishop Hall Mill Pond

The Remediation Project

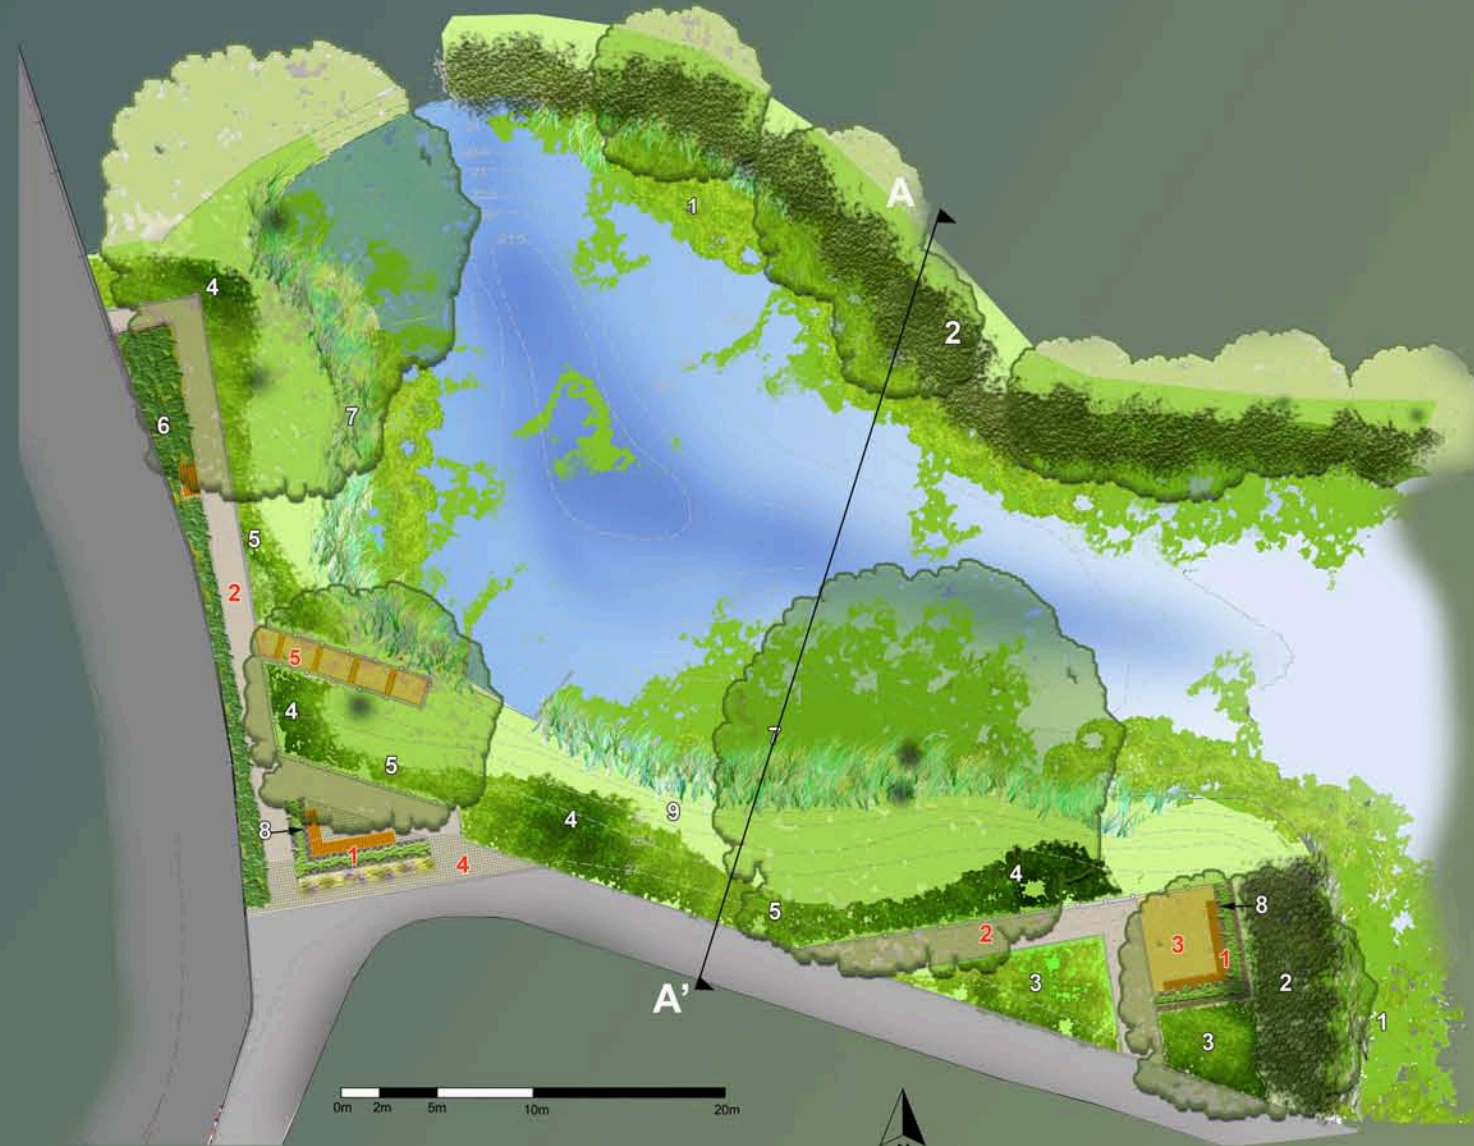
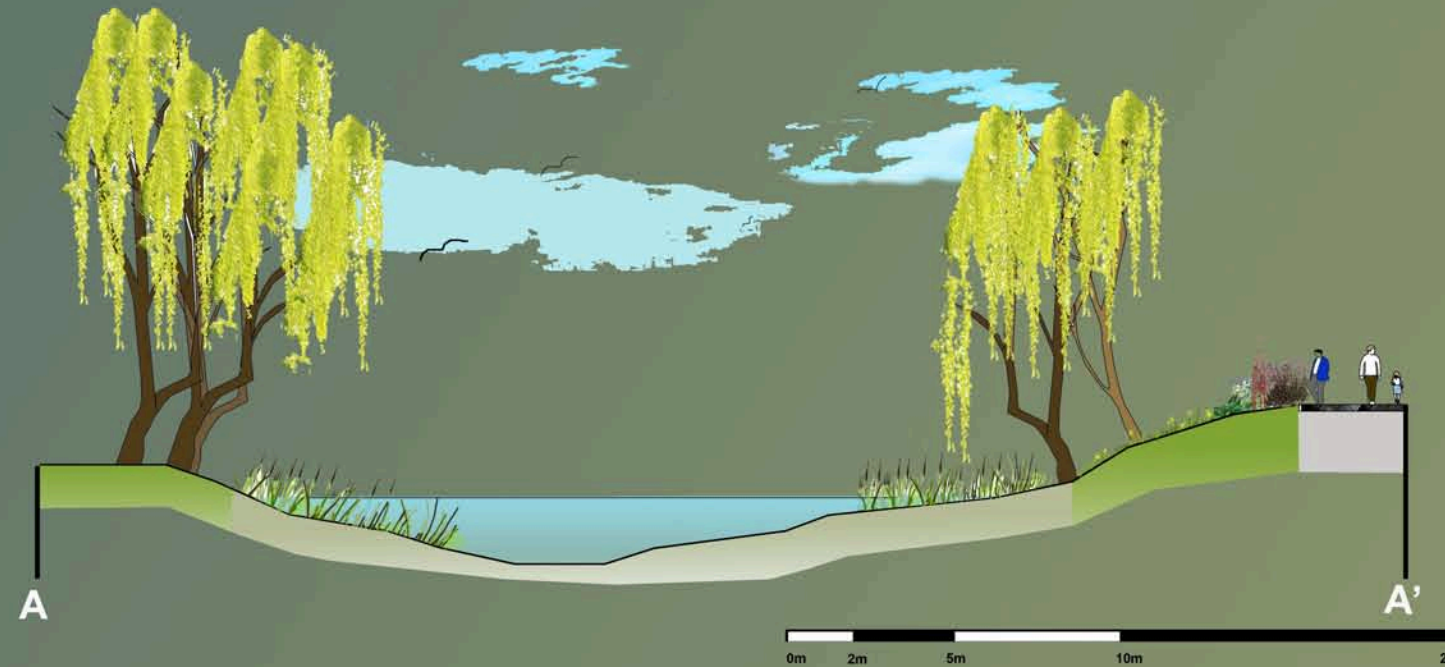
The outfall of the roads adjacent to the pond have deposited elevated concentrations of hydrocarbons. These are to be removed as part of the dredging process and treated off-site prior to potential re-use or deposit at land fill.
